## A Study of Site Planning Integrated with Sustainable Stormwater Management in the Scale of District -Comparative Analysis Utilizing 3D Measurement Technology Part1-

Adaptation for Climate Change, Site Planning, Sustainable Storm Water Management, 3D Measurement technology, Built Environment

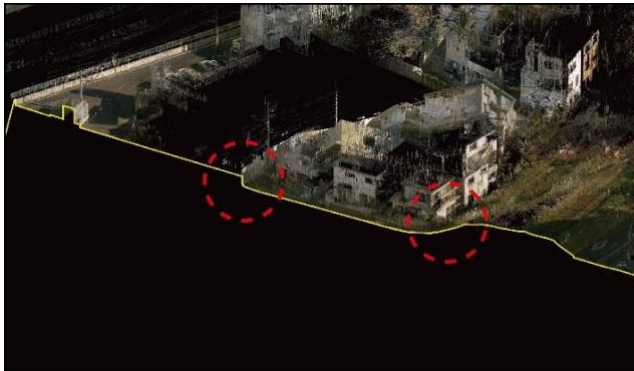
Fig. 8. 3D section of Kuji area 1

The right edge of Figure 8 shows the differences of levels, indicating that the center of this area is lower than the surrounding area. Figure 9 shows that the center of the area is also lower than the surrounding area, and the parking lot appears as if it is dug in. The Kasumi-tei that was constructed in the 18th century, is remaining in this area. Kasumi-tei is one of the traditional Japanese flood control measures to reduce damage to residential areas. By installing Kasumi-tei kinds of dike at certain distances from rivers and intentionally leading floodwaters between the Kasumi-tei and the rivers. Therefore, the level of the area between the Kasumi-tei and the river was originally lower than the surrounding area, and thus, it is vulnerable to flood damage. However, from the middle of the 20th century, the area between the Kasumi-tei and the Hirase River transformed residential area. In addition, the top level of Kasumi-tei on the right side is higher than the river bank on the left side, as shown in Figure 8. Therefore, the situation constrained by the surrounding ground levels makes it difficult to drain stormwater once it flows into the area. This topographical feature increases the damage from inland flood at the time of the 2019 disaster, this area had some overflow flood in addition to the inland flood. It is presumed that the water level in the Hirase River was rising very close to the breakpoint at that time. It is also presumed that the water level of the Hirase River is higher than the water level in the aforementioned area shown in Figure. 8, and thus, it was very difficult to drain the stormwater once it flew into the area. Therefore, in the Kuji area with the remaining Kasumi-tei, the situation constrained by the surrounding ground levels made it difficult for stormwater to drain out and caused more serious damage.
