By Rail And Mail: Understanding The Significance of Colonial Architecture for Mass Transport and Communication in The Philippines

Caryn Paredes-Santillan¹, Michael F. Manalo², John Clemence M. Pinlac¹

¹UST College of Architecture, Philippines ²USTGS-CCCPET, Philippines

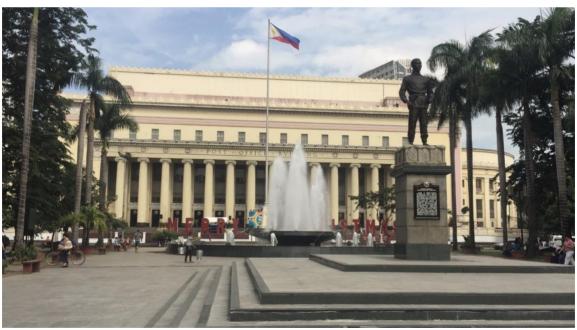
Figure 1. The Manila Central Post Office Building [13]

The MCPOB comprises a rectangular block with two smaller lunettes abutting the narrower ends. This is set upon a raised dais and accessed in front by a flight of stairs. The building facade is symmetrical, and the formal composition is centralized.

The building employs a neoclassical temple-style facade, with Ionic dodeca-prostyle in antis. The rest of the building follows the neoclassical block composition, with classical patterns repeated at various levels. The fourteen Ionic columns on the facade are set upon an octagonal base and spaced evenly on the front portico. Instead of supporting a pediment, the entablature juts out slightly from the facade. The narrow windows on top of the entablature are aligned with the gaps between the columns, giving the gaps the illusion of continuity.

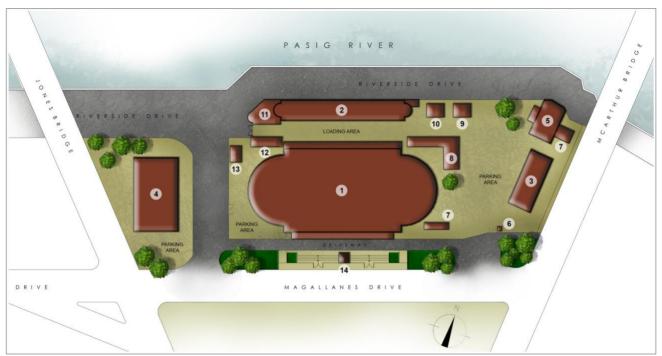
Figure 2. The existing Site Development Plan of the PHLPost Complex is bounded by the Pasig River on the Northwest, Jones Bridge on the West, Magallanes Drive on the South, and McArthur Bridge on the East. The existing buildings inside the property are listed as follows: (1) Manila Central Post Office Building; (2) Annex Building 1; (3) Annex Building 2; (4) Postal Bank Building; (5) Old Property Building; (6) Guard House; (7) Generator Room; (8) Health Services Building; (9) Driver's Quarters; (10) Gas Station; (11) MMDA Pumping Station; (12) Security Headquarters; (13) Fire House; (14) Flag Pole [13]

During the early American colonial period in the Philippines, American planner Daniel Burnham created a Plan for Manila based on the tenets of the City Beautiful Movement. In it, he specified the site of the MCPOB on the Pasig River's South bank at the end of Padre Burgos Drive. Plaza Lawton is at the front of the property, where Magallanes Drive extends toward and widens right in front of the MCPOB to form the "plaza." Pasig River is located toward the property's rear and includes a formal embankment for deliveries and dispatch by water.

The most notable rectification of the original design was done by adding a ramp for vehicles parallel to the portion of Magallanes Drive passing in front of the Post Office Building. This answered a then-current need to provide infrastructure for being dropped off by motor vehicles, given that the number of cars in Manila was on the rise then. The ramp split the grand flight of steps leading to the main entrance into two parts, creating the illusion that the MCPOB has a basement.
