## A Study of Site Planning Integrated with Sustainable Stormwater Management in the Scale of Building -Comparative Analysis Utilizing 3D Measurement Technology Part2-

Adaptation for Climate Change, Site Planning, Sustainable Storm Water Management, 3D Measurement technology, Built Environment

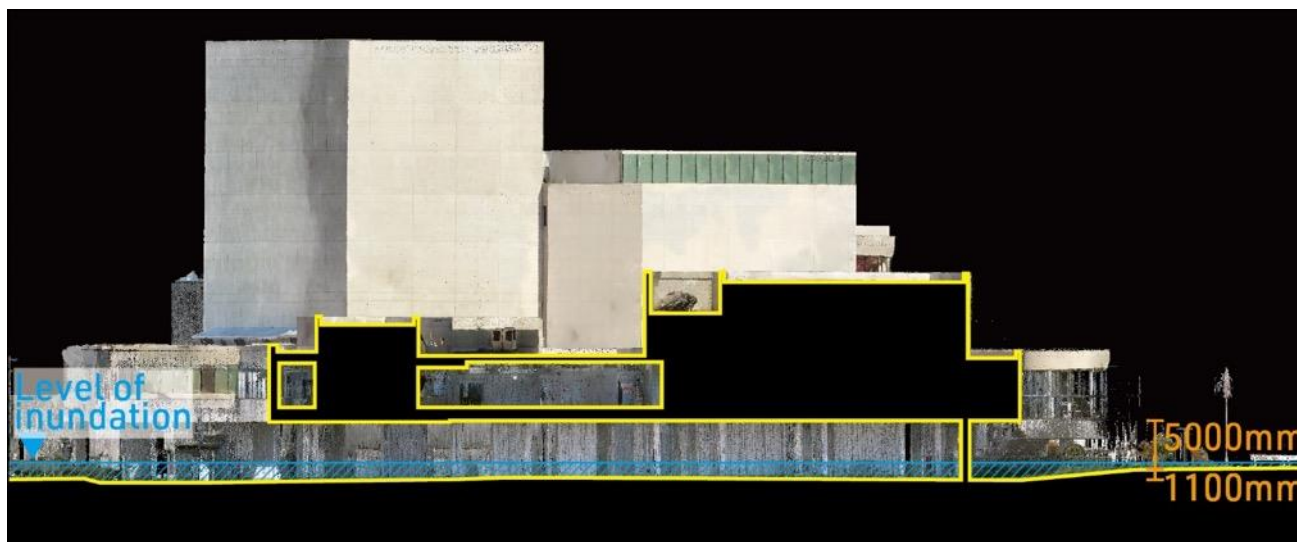
Fig. 13. Section of Miyoshi Civic Hall Kiriri

Jun Aoki has won the open proposal to select the architect and designed the Miyoshi Civic Hall Kiriri. 35 applicants submitted their plans for the open proposal. Mr. Aoki was the only one who considered the risks of the site for water-related disasters and proposed a scheme that includes the countermeasure to the disaster. He designed the Miyoshi Civic Hall Kiriri in such a way that the entire building was elevated 5,000 mm from the ground level (Figure 13). His intention for this design was to avoid damages caused by the potential flood of maximum 5-meter height as shown in the hazard map. The detailed hazard map for flood was published by the local government and indicated the risk at the time of the proposal.
